NASA Contractor Report 4664

# Analysis of Materials Flown on the Long Duration Exposure Facility: Summary of Results of the Materials Special Investigation Group

*H. Gary Pippin*

*H. Gary Pippin*  
*Boeing Defense & Space Group • Seattle, Washington*

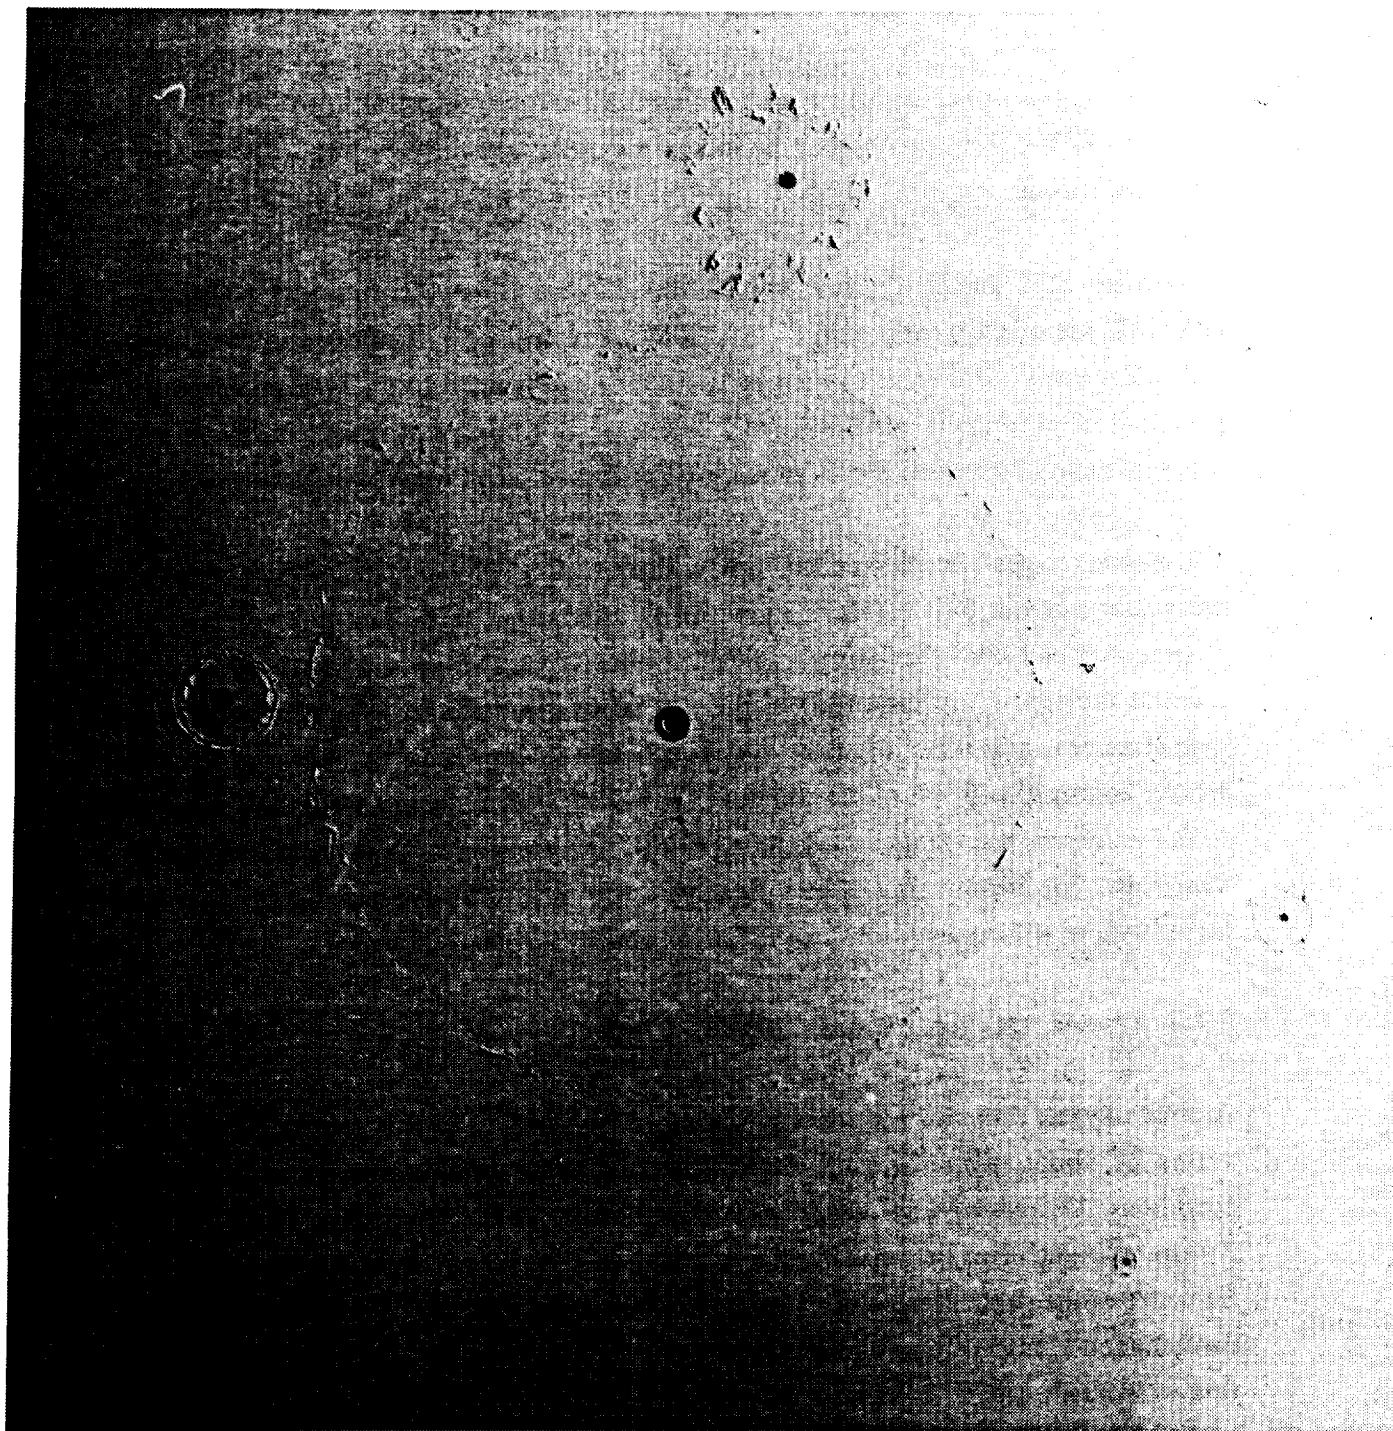
Impacts on leading edge painted surfaces removed relatively large areas of loose paint in comparison with the size of the impact crater. This occurred because the paints' organic binder was lost due to atomic oxygen exposure prior to the time of the impact. Figure 5.1-1 shows an example of this loss of paint from the A276-paint-coated composite panel from AO038 experiment on tray F6. Notice that the entire paint layer was not lost; this may be a way of "dating" the time of impact because previously degraded layers were much more easily removed due to the impact, especially at distances relatively far from the impact site. Precise measurements of the depth of the removed layer relative to nearby unimpacted areas would be required. The example in figure 5.1-1 likely occurred quite early in the mission prior to atomic oxygen removing all the binder.

Figure 5.1-1. Painted composite panel from A0038 with impacts visible on one of the white painted areas. (Color figure C-1)

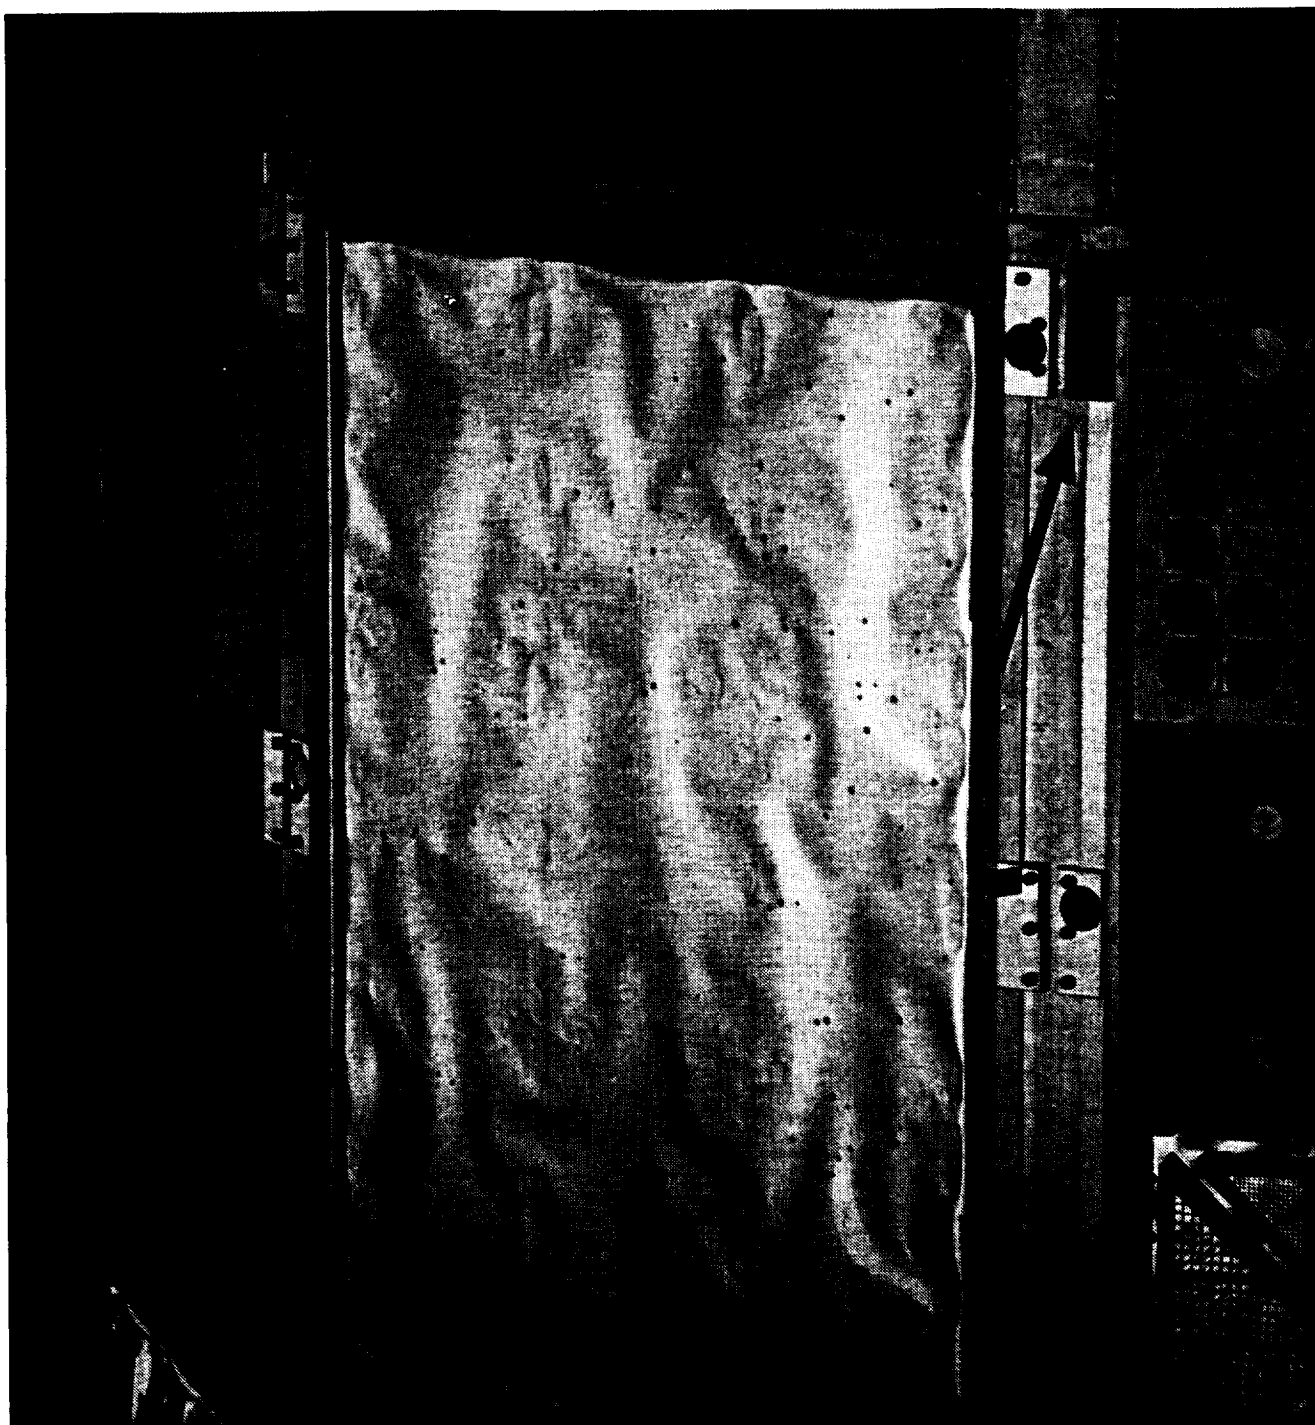
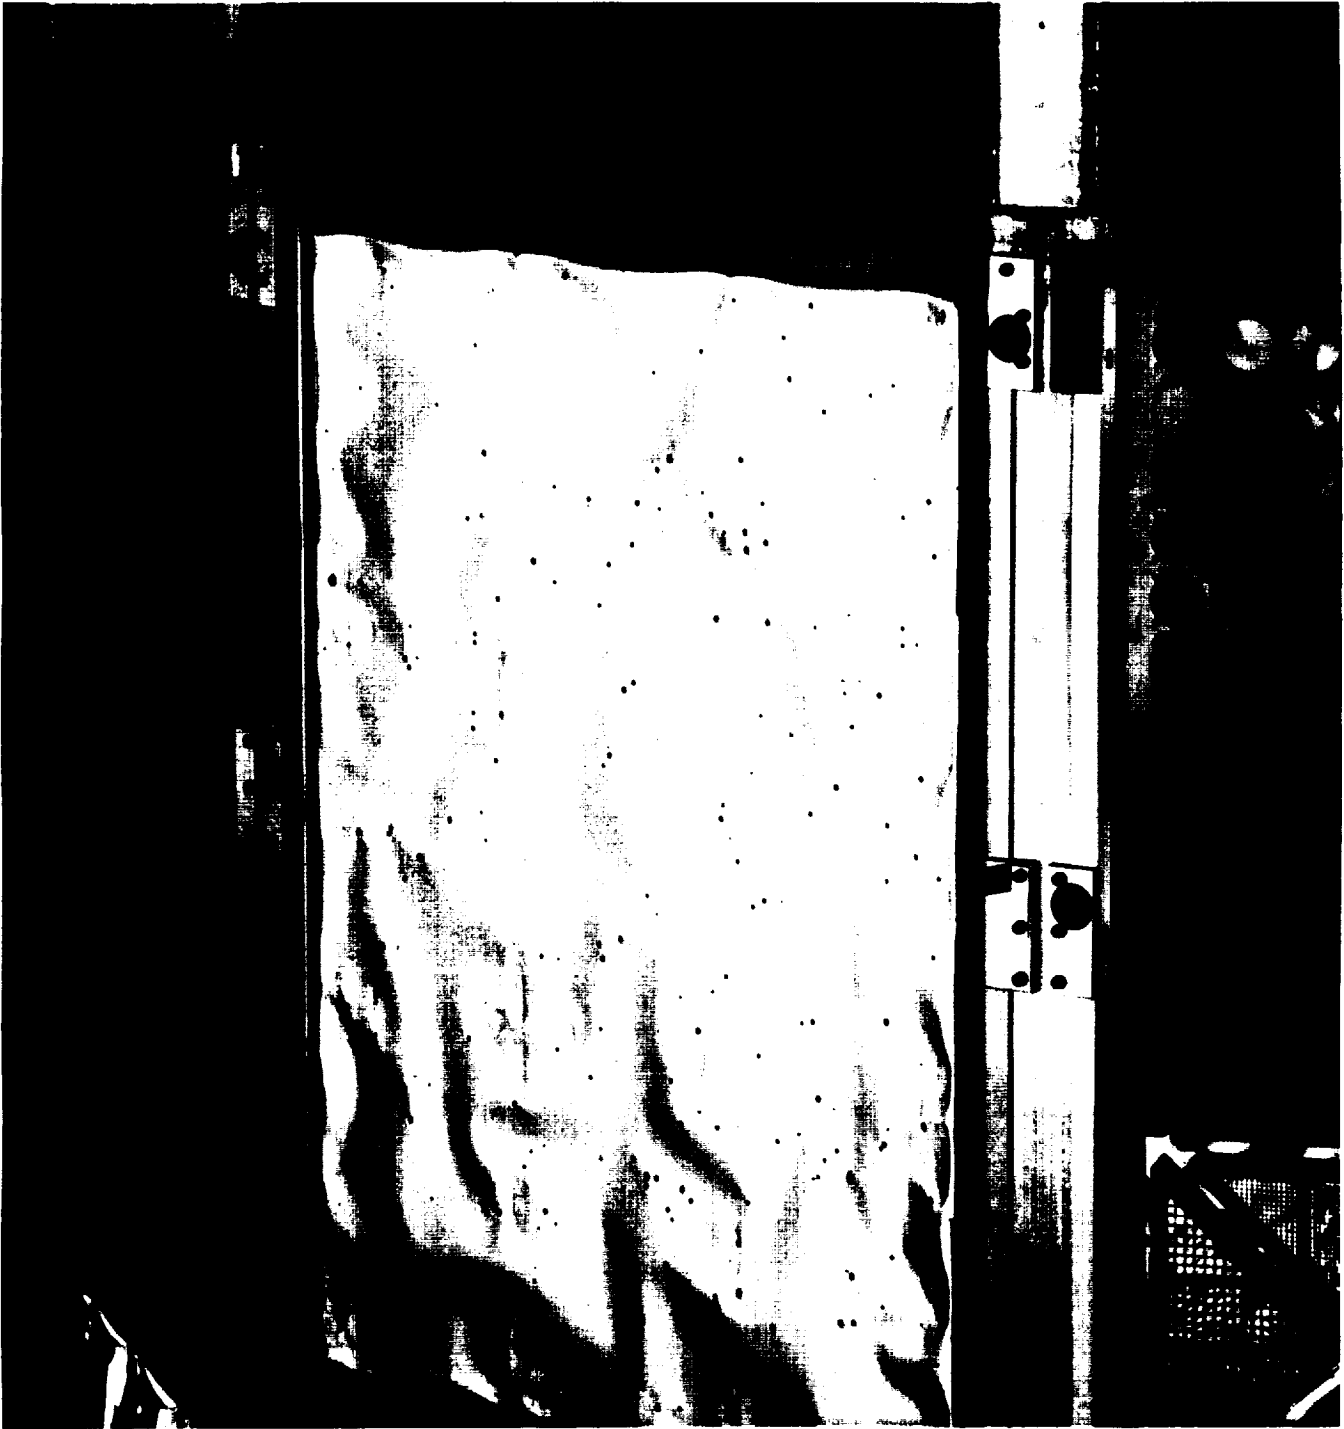
The "L" shaped angle bracket in the upper right corner of figure 7.1-1 is one of the few unanodized tray clamps. This clamp is distinctly darker in appearance from the more typical anodized clamps. This darker appearance is due to its as-manufactured condition and was not due to LEO exposure. The poorer optical properties of untreated aluminum was the reason for anodizing the structure.

Figure 7.1-1. NASA on-orbit photo of thermal control blanket on tray C8, also showing the unanodized tray clamp on C9. (Color figure C-2)

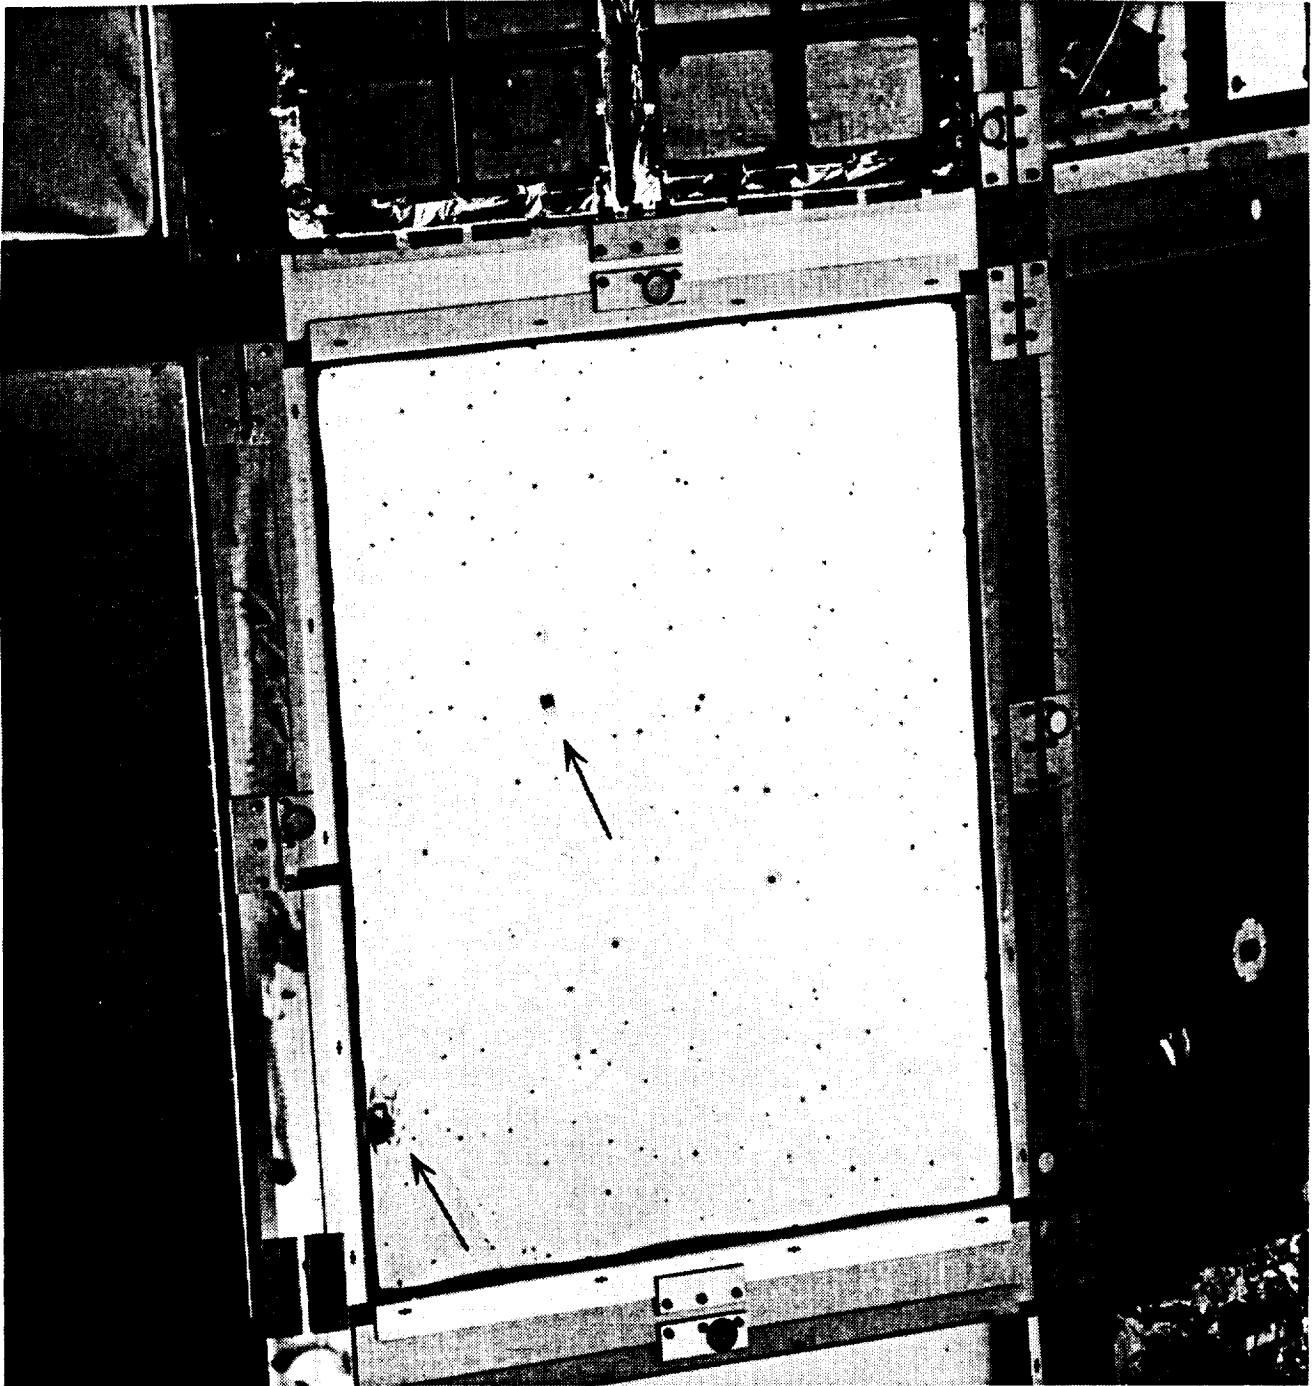
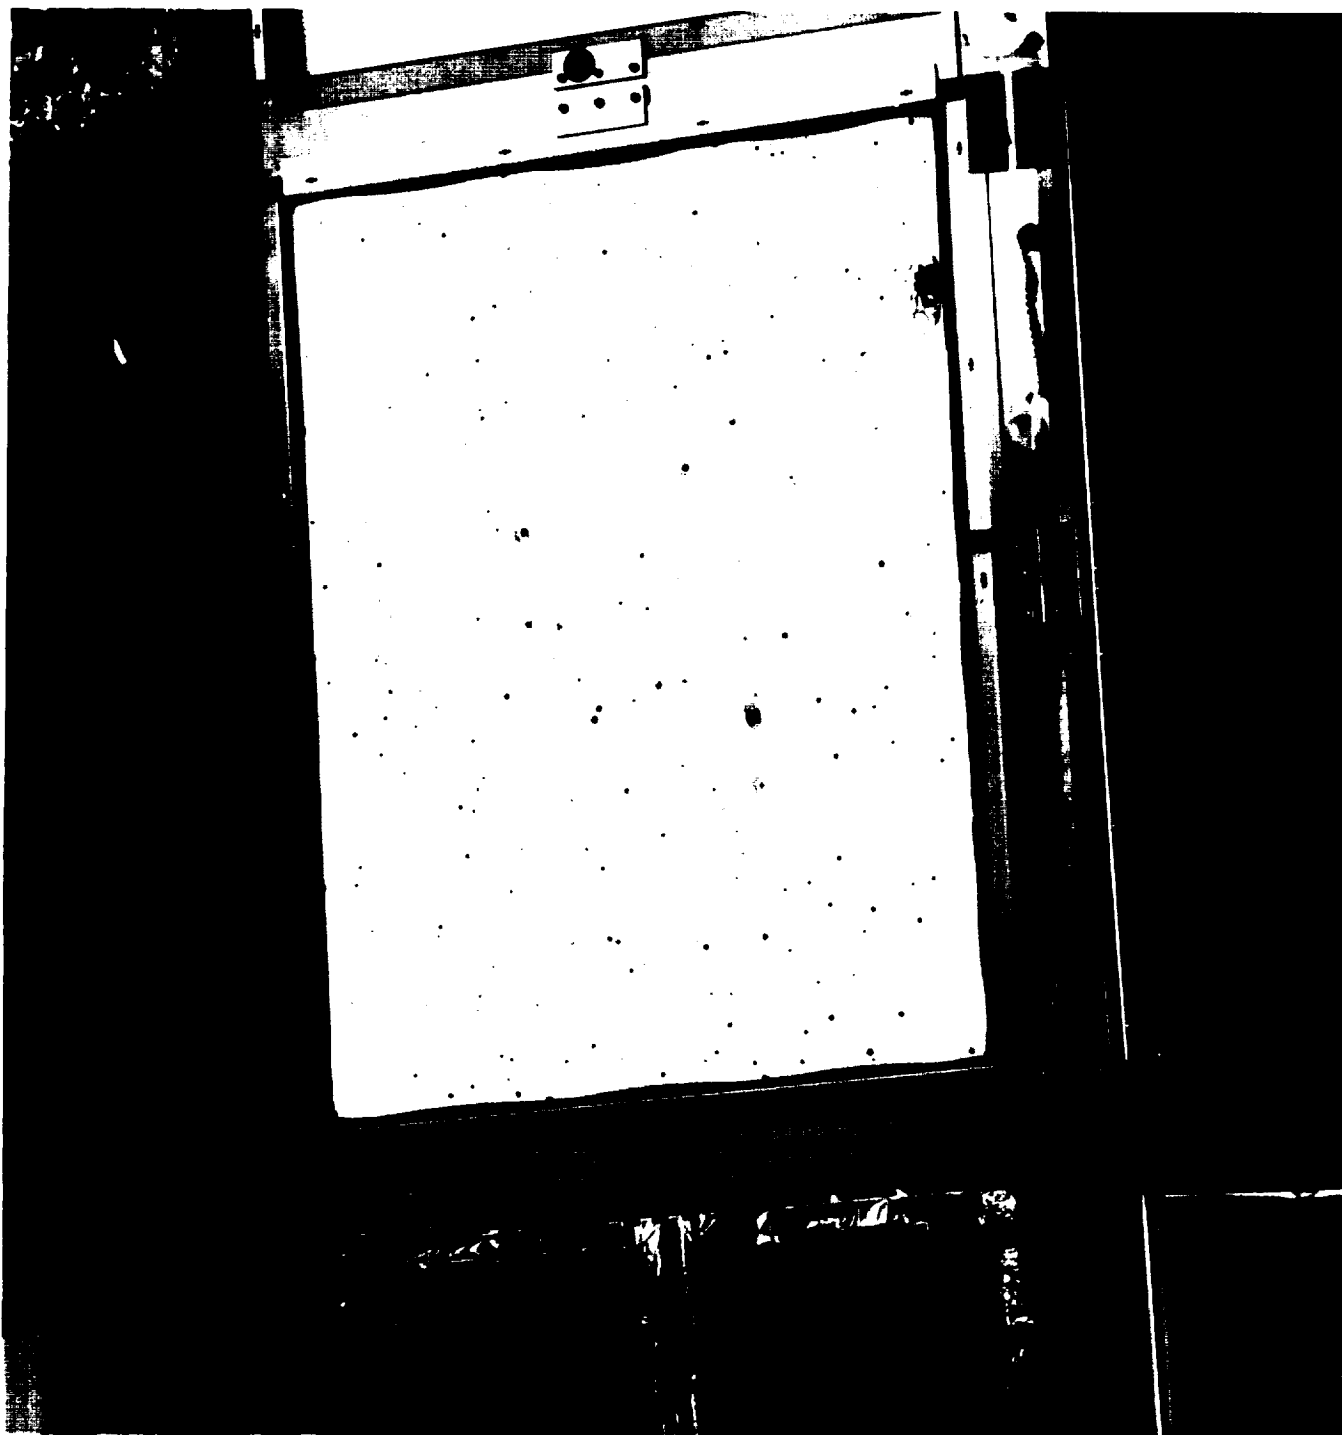
The NASA on-orbit photo in figure 7.1-2 shows the center tray E10 with a particularly large damage area toward the row 11 side of the tray. A second large damage area, associated with underlying velcro, is visible toward the center of the tray. Impacts at locations on the silvered Teflon blankets with underlying velcro tended to produce much larger damage areas in comparison with impacts at unsupported locations. This is likely due to reflected shock waves from the underlying hardware.

Figure 7.1-2. NASA on-orbit photo of tray E10 showing large impacts on areas supported by velcro. (Color figure C-3)

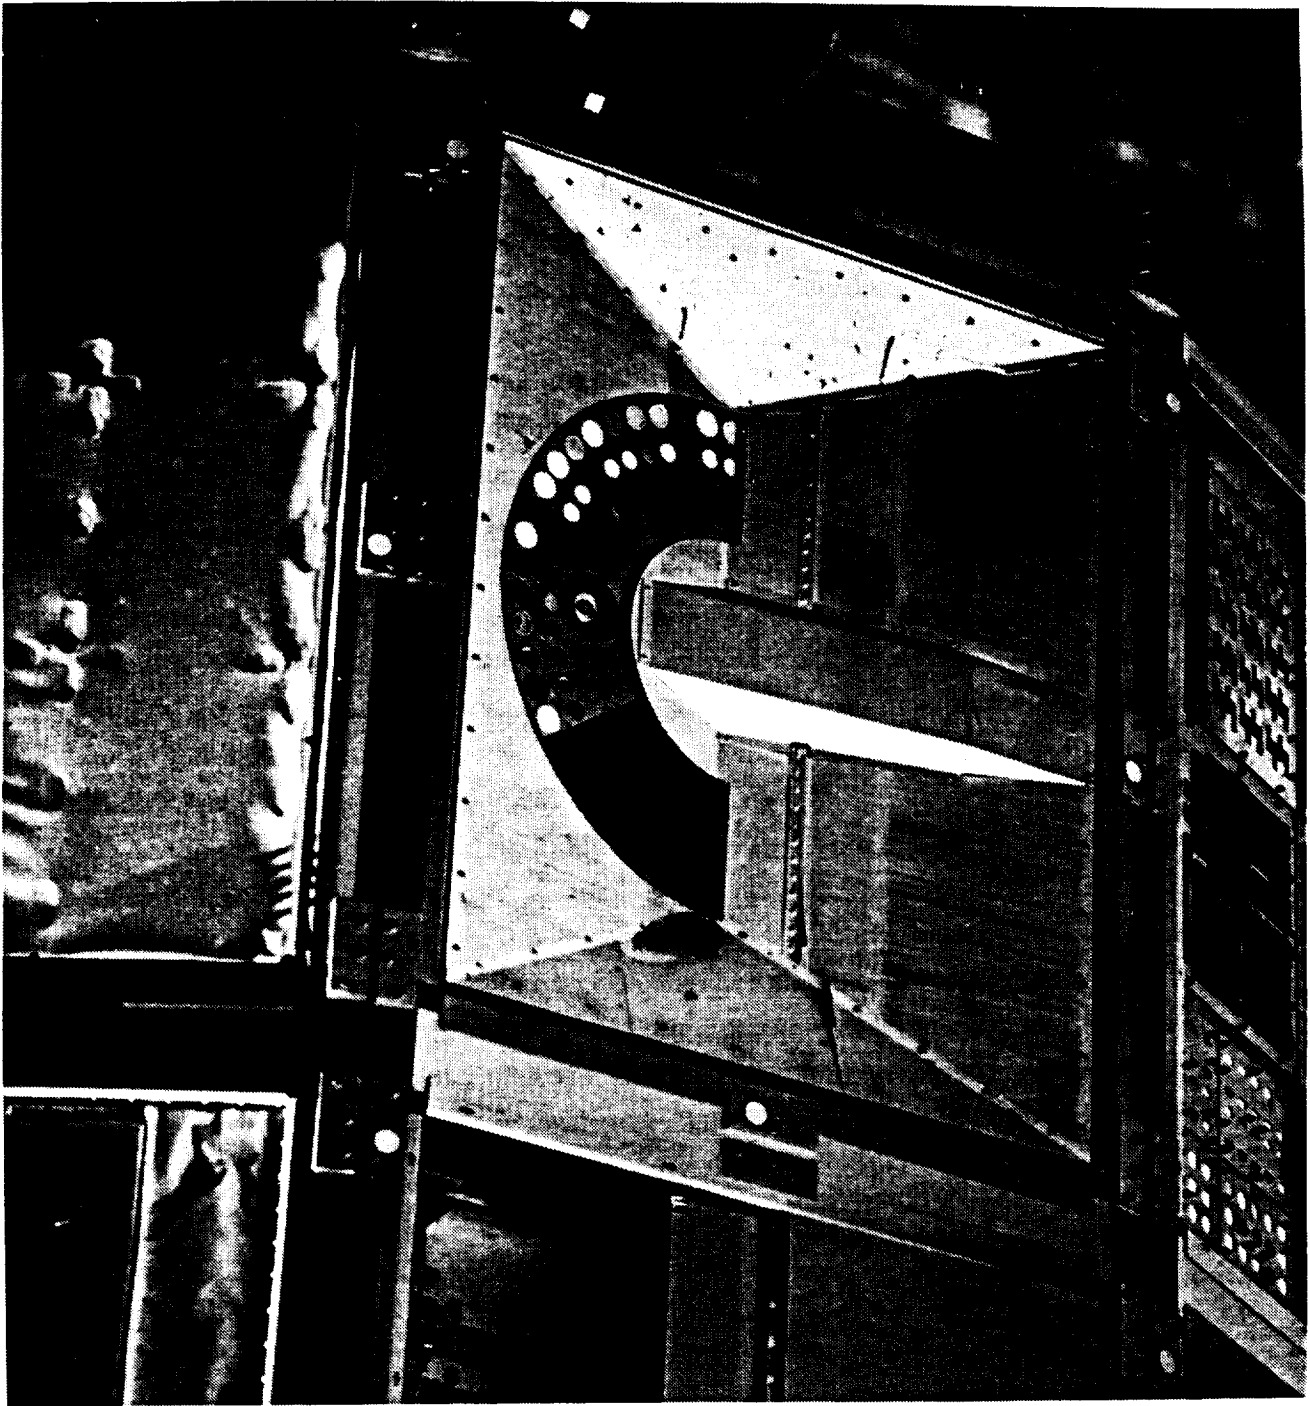
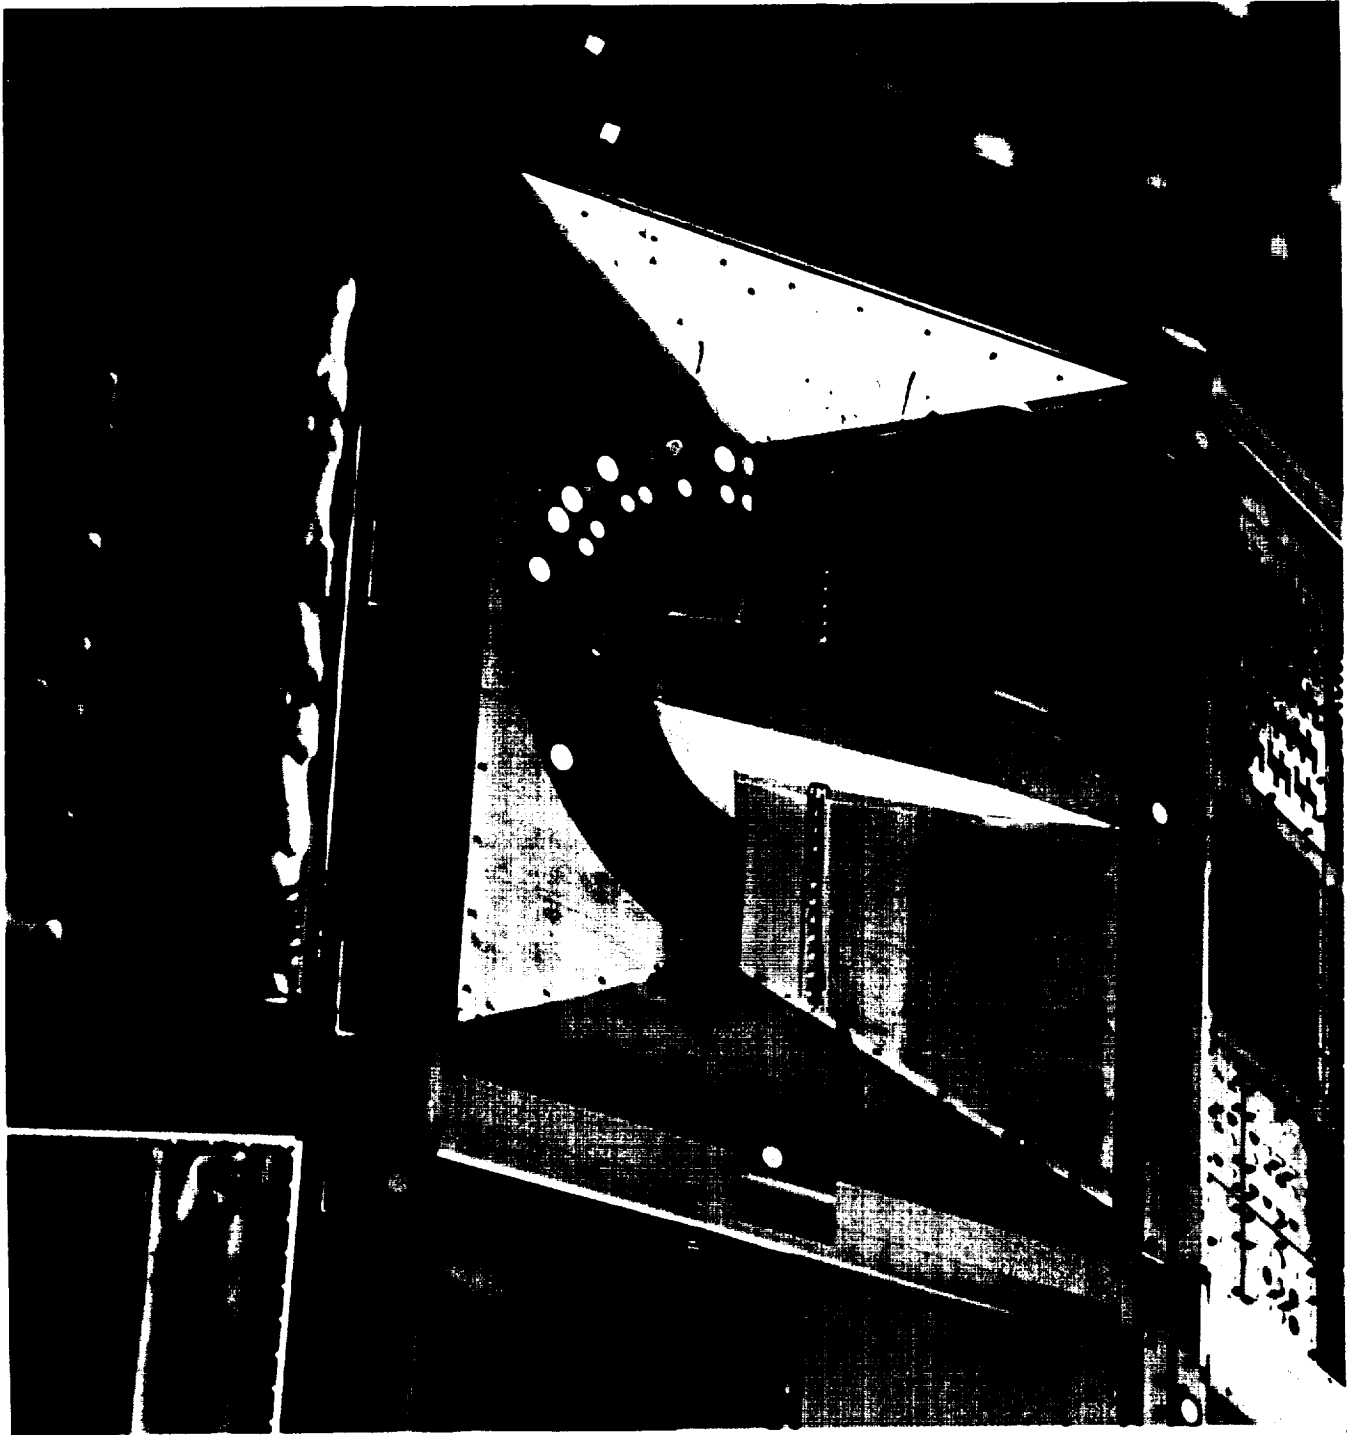
The NASA on-orbit photo in figure 7.1-3 shows tray A9, containing experiment S0069. The streaking of the thermal control material due to solar-induced darkening of adhesive which had bled through cracks in the silver-Inconel layer is visible. The adhesive is trapped between the FEP and silver layer. The cracks were formed during the application process. The silverized Teflon is also very diffuse due to the roughening of this surface by atomic oxygen. The rough texture gives the material the diffuse, milky appearance. This is also shown by the white, milky appearance of blanket A10 (to the right).

Figure 7.1-3. NASA on-orbit photo of tray A9, containing experiment S0069.

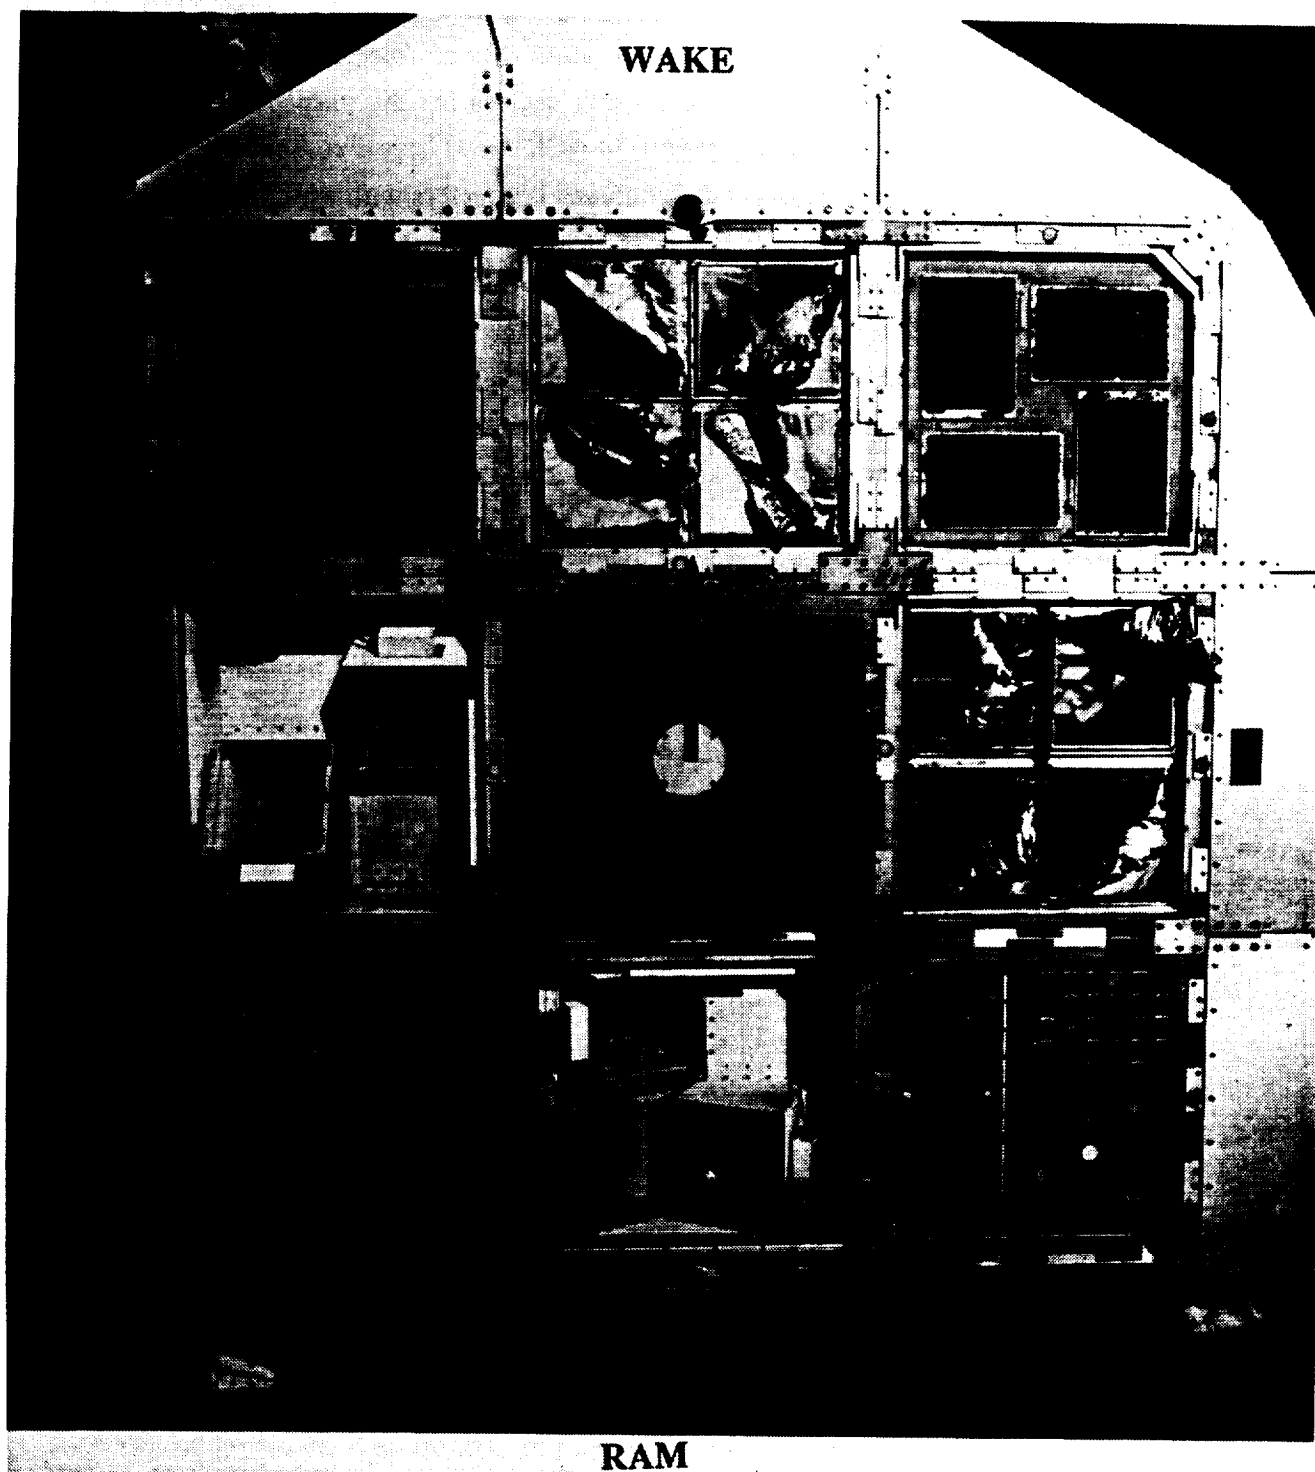
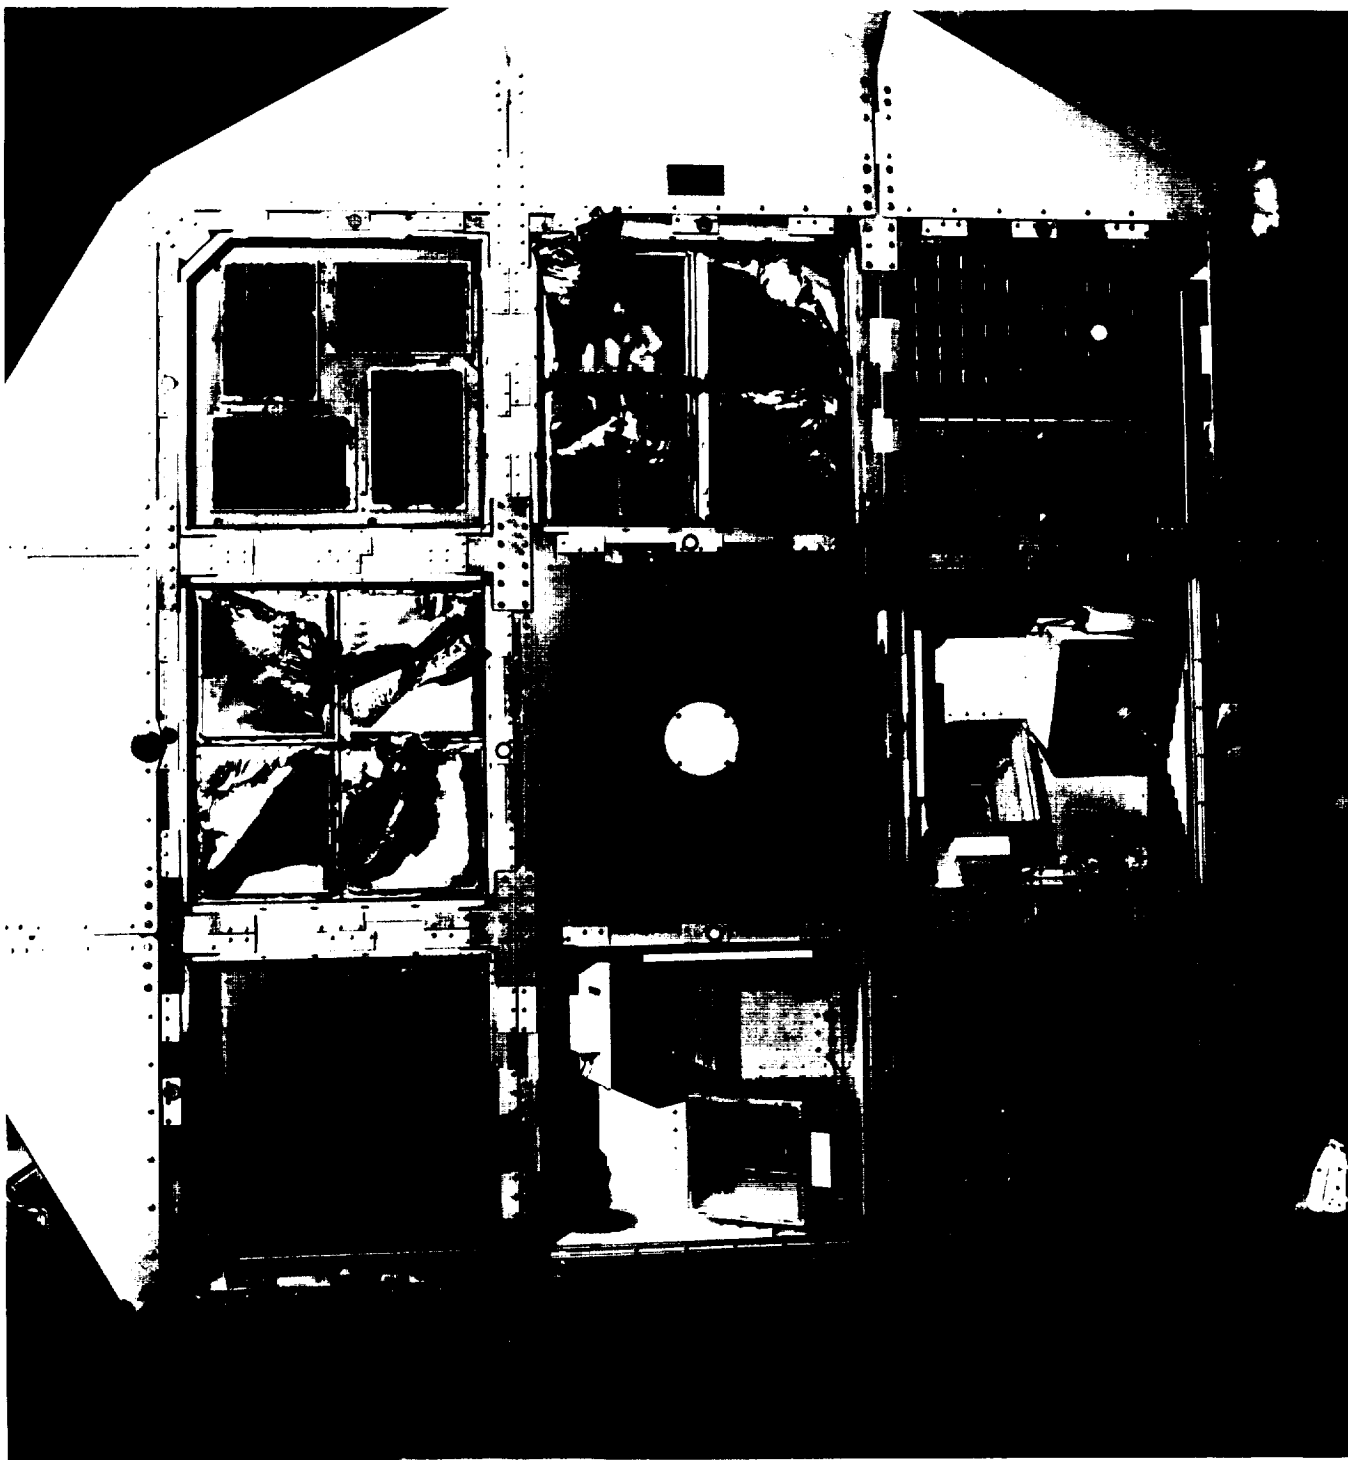
The space end on-orbit photo in figure 7.1-7 shows the failed thermal control blankets on the M0001 modules. These modules are indicated by the arrows in the figure. The darkened, brown areas on these modules are Lexan polycarbonate track detectors which were exposed to solar radiation, leaving those areas useless for the purposes of this experiment. The AO038 Interstellar Gas Experiment (IGE) trays have a number of areas discolored by contamination deposits, particularly around connectors with wire feeds from the interior of the tray. It is also significant that large areas coated with A276 white thermal control paint have not significantly discolored, in spite of the over 14,000 equivalent hours of direct solar exposure. The lighter discoloration patterns are each in the half of the tray toward the trailing edge. Areas which remained visibly white are toward the leading edge. The oxygen exposure for these locations is still quite low, about  $5 \times 10^{19}$  atoms/cm<sup>2</sup>, but mostly occurred late in the mission and was apparently enough to remove the very thin UV damaged binder layer.

Figure 7.1-7. NASA on-orbit photo of M0001 experiment modules on space end.  
(Color figure C-7)

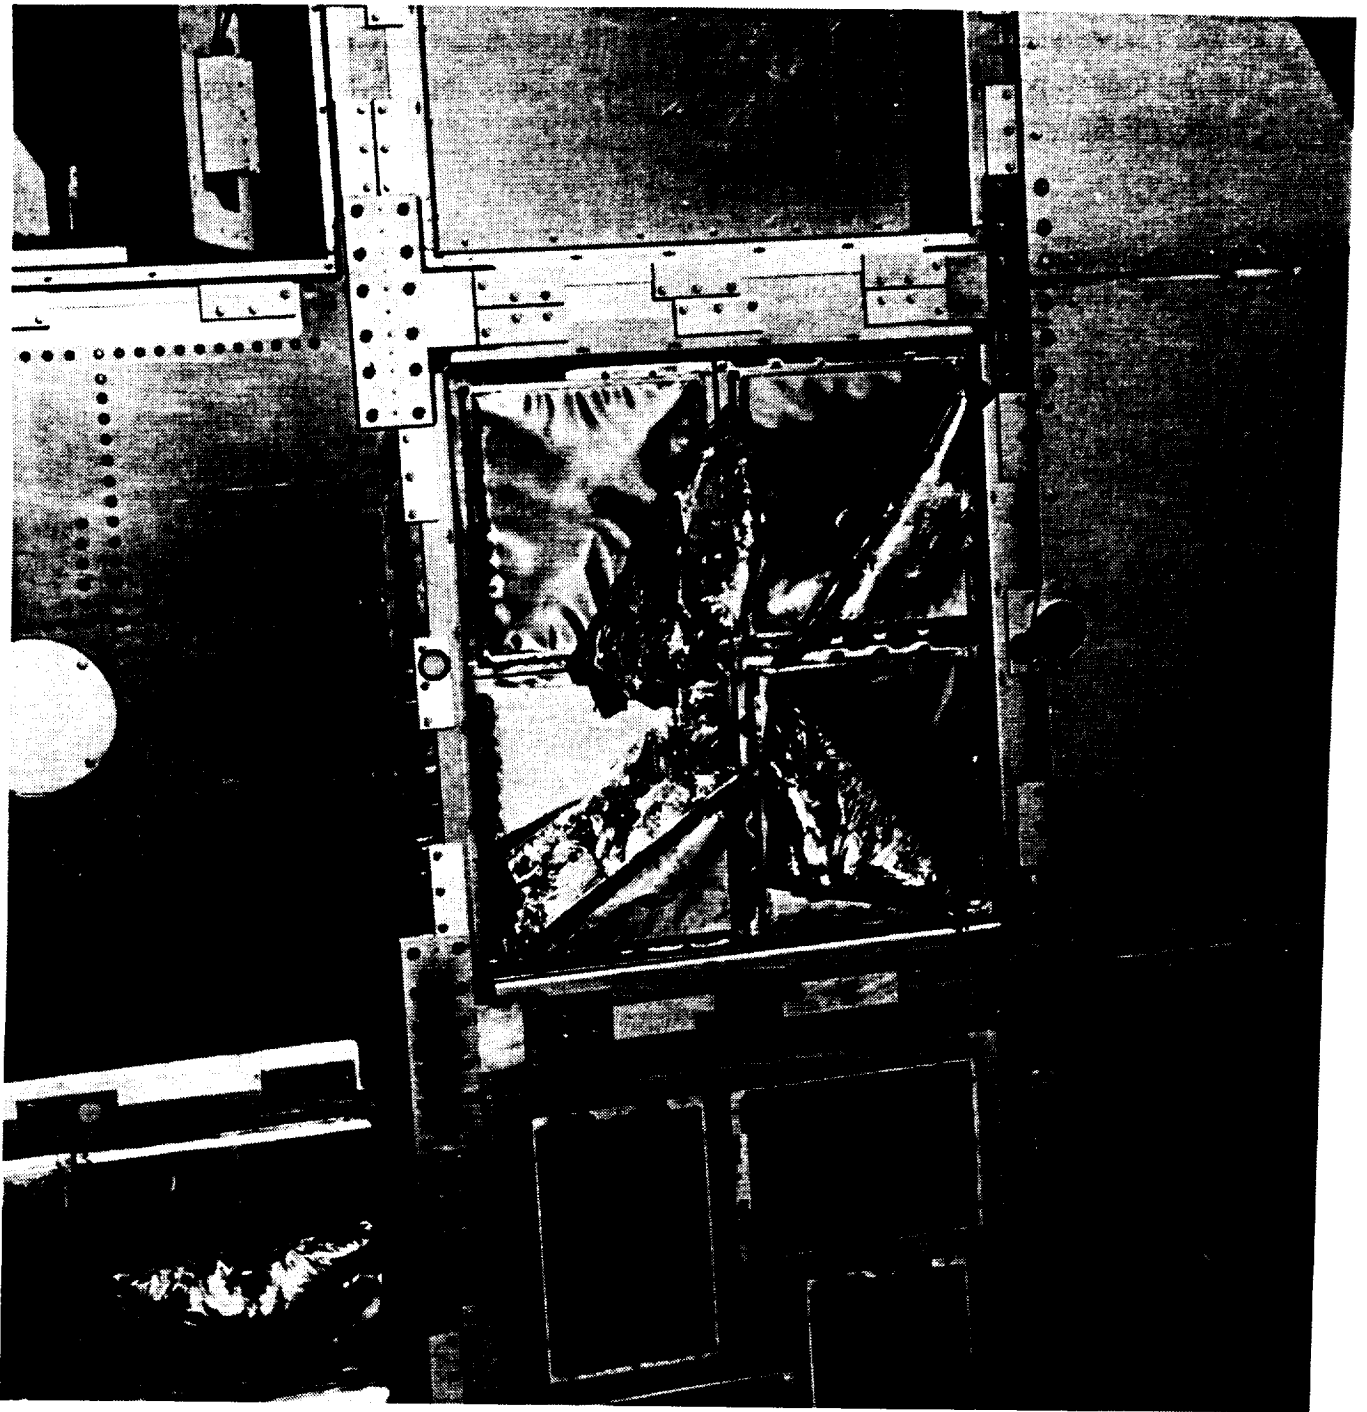
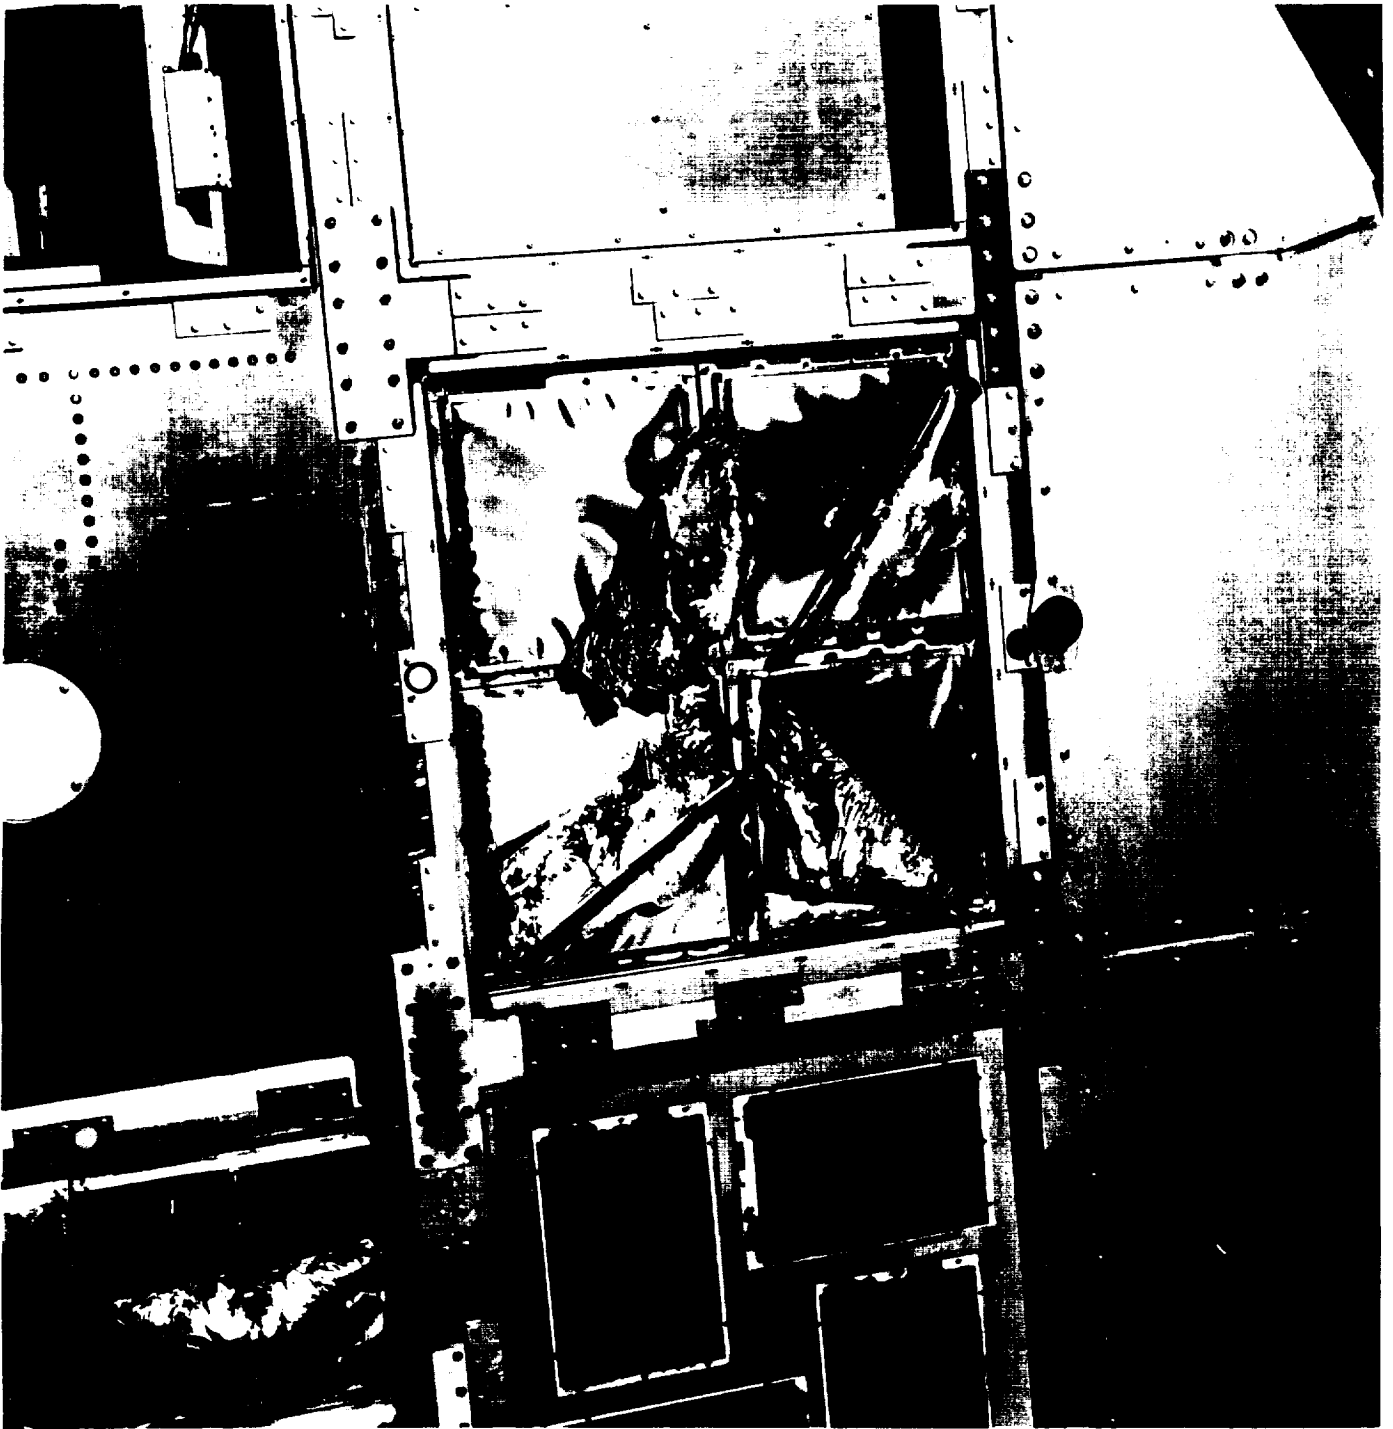
Figure 7.1-8 is a close-up on-orbit photo of the failed thermal control blankets on an NRL M0001 experiment module. At the lower right are the solar arrays which recharged a NiCd battery used to power the NASA Goddard heat pipe experiment. These arrays operated during the entire flight.

Figure 7.1-8. NASA on-orbit close-up photo of failed thermal control blankets on space end. (Color figure C-8)
